# Manhole Inspection Summary

Manhole # S25WW1042MH

Record Plat: **25WW1** Node: **042** Status: **New Manhole (Not in GIS)** Insp Date: **5/22/07 2:24 PM**

**Location** Address: **106 LONGWOOD RD**

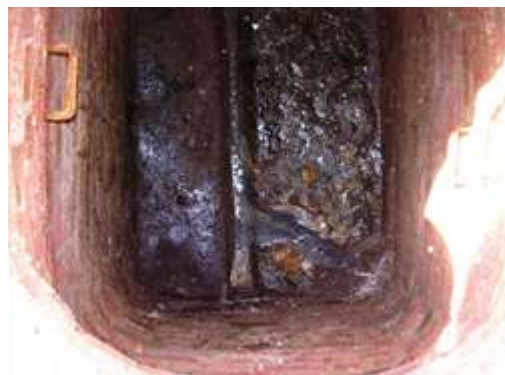
Top View

☒ **Debris** (not Condition related)

☒ **Corroded**

Corroded steps. Bench debris.

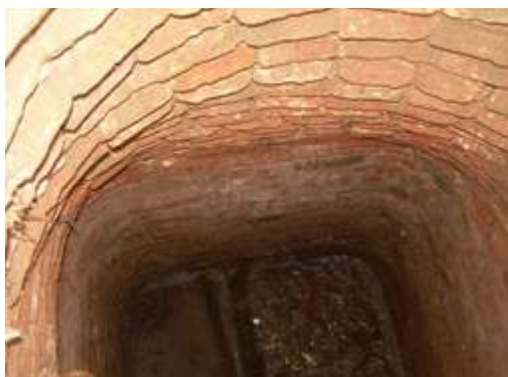
Defect

Infiltration: ☐ None ☒ **Joint** ☐ Cracks ☐ Mortar ☐ Roots ☒ **Wall**

Infiltration: ☐ None ☐ Joint ☐ Cracks ☒ **Mortar** ☐ Roots ☒ **Wall**

Adjustment, Corbel and Barrel infiltration.

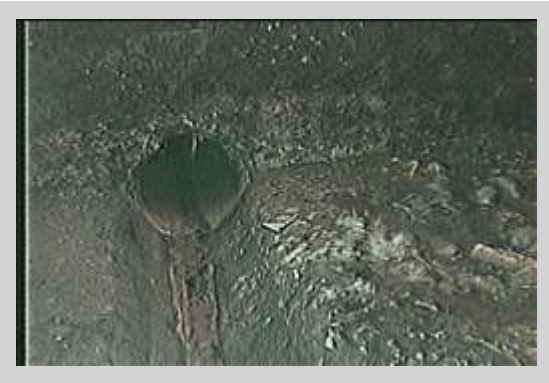
### 8 in. Circular Gravity Sewer Pipe Out @ 12 O'Clock

Condition: ☐ Sound ☐ Cracked ☐ Root Intrusion ☐ Loose Brick ☒ **Deteriorated**

Infiltration: ☐ None ☐ Joint ☐ Cracks ☒ **Mortar** ☐ Roots ☒ **Wall**

Barrel deterioration and infiltration.

Infiltration: **None** Pipe Seal Cond: **Roots**

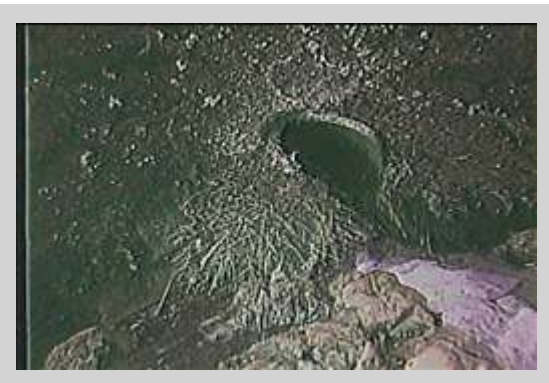
### 6 in. Circular Gravity Sewer Pipe In @ 4 O'Clock

Deposits: ☐ None ☐ **Mud** ☒ **Sludge** ☒ **Debris** ☐ Grease

Silt Depth: **1** (in.) Deposits Extent: **Heavy**

Infiltration: **Evidence** Pipe Seal Cond: **Roots**

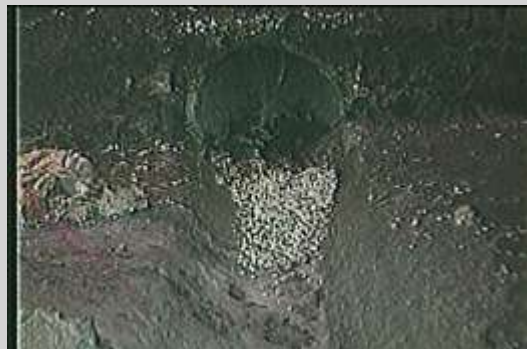
4 in. Circular Gravity Sewer

Deposits: ☐ None ☒ **Mud** ☐ Sludge ☒ **Debris** ☐ Grease

Silt Depth: **1** (in.)

Deposits Extent: **Light**

Pipe Seal Cond: **Roots**
